Subject: As-Built Plan Review  
1 Godwin Ave., LLC  
Sola Salon  
1 Godwin Ave.  
Block 3, Lot 24.01

We have received a revised as-built plan of the subject property prepared by Page Consultants, Inc., revised 7/12/23. We have visited the site and reviewed the plan.

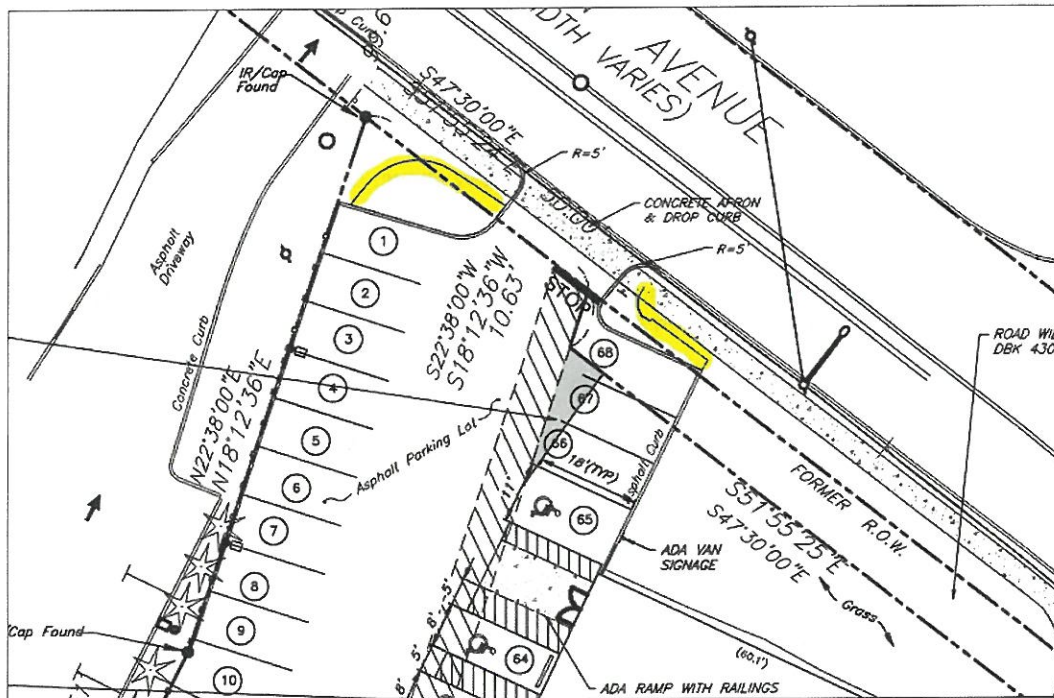
1. As shown on the as-built plan, these highlighted areas represent the old edge of pavement at the Godwin Ave. driveway. These old lines should be removed from the as-built drawing.

The as-built survey has been revised as requested.

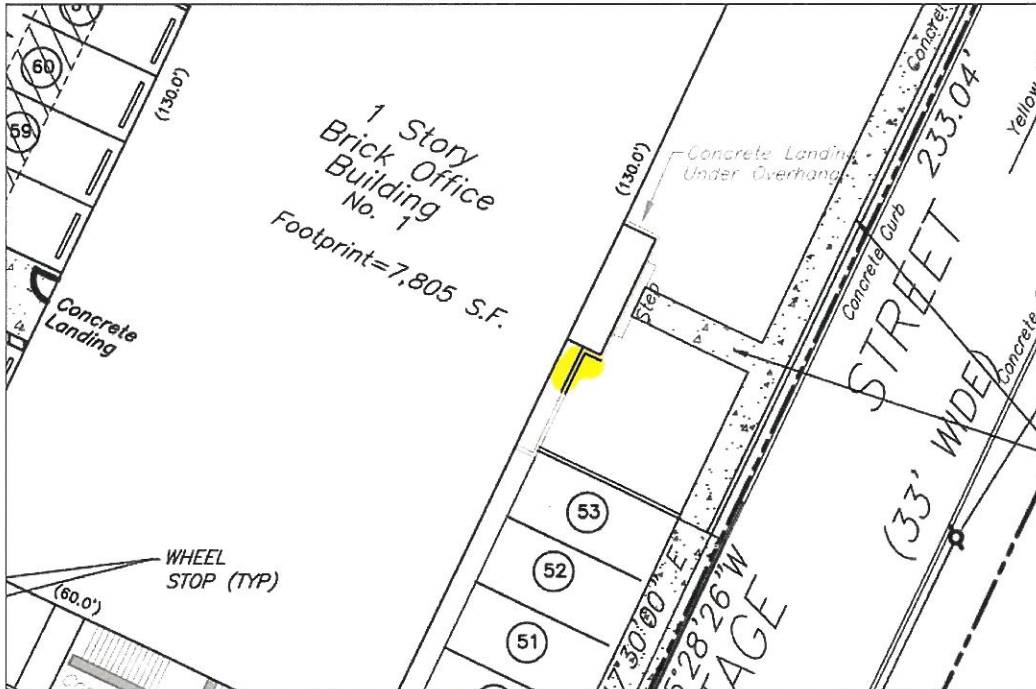
2. This highlighted area does not appear to be accurate. There are natural stone landscape walls on either side of these stairs. Accurate as-built conditions should be shown on the as-built plan.

The as-built survey has been revised, and now appears to accurately reflect the as-built conditions.
